Analysis of injector spring damage to determine maintenance management diesel engine at PLTD Ampenan

Abstract. The injector spring in cylinder #2 of a diesel engine in Ampenan PLTD which is operated by PT. X damaged. After visual inspection, a helical spring of the injector was broken. The spring broke in the lower part, in winding 2 of the spring. Before the damage was known, with a diesel load of 1100 kW, the exhaust manifold the cylinder #2 was glowing. Root cause analysis of the broken spiral spring was carried out by visual observation, metallography, and maintenance management analysis. Results indicated that the damaged of the broken injector spring based on visual observation of the helical spring was due to alternating bending loads. The fracture angle was at 45° indicated a bending load. Benchmark shows the beginning of the fault, followed by a static fracture. Metallographic and microstructure examination results found too many sulphides possibly making the formation of the onset of the fatigue. To minimize the damage, the sulphide amount of the spring must be reduced, and the spring injector material must be redesigned. Maintenance management must check every time the

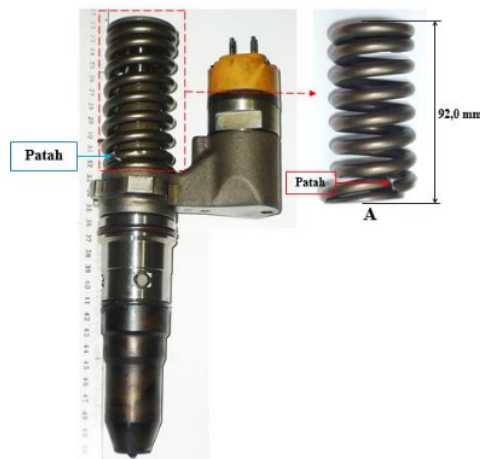
In a visual inspection of a spiral spring injector, A \varnothing wire diameter 7.0 mm and \varnothing 48 mm spring circumference has a broken first circle.

Figure 4. Macro photo injector.

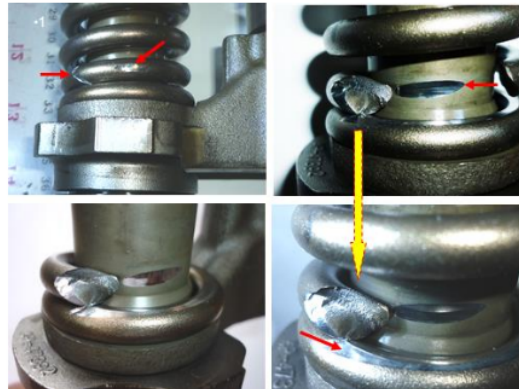
Photo macro image 8 on the injector spring the broken center point is a load bearing area and includes a fairly high center of stress concentration, it can be seen from the circumference area of the fracture there is a defect between the spring and spring wear.

Figure 5. Photo macro on the injector fracture surface.

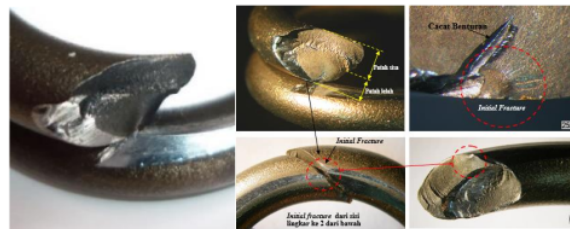
Figure 6 spiral spring circle 2 is the beginning of a fracture which first occurs the bending load thinning, while the shape of the fault has a 45° angle is a static fracture, while the 7 benchmark image on the injector spring fracture.

Figure 6. Early broken.

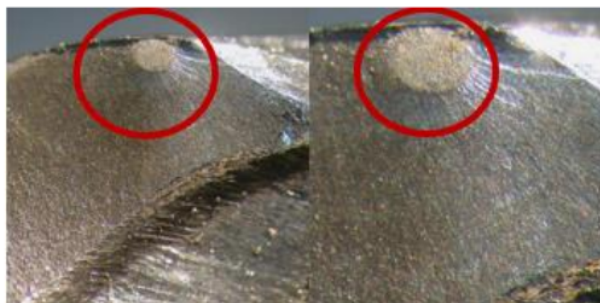
Metallographic testing Figure 7 describes a benchmark that occurs in a spiral spring, that a benchmark indication is a form of fatigue in the injector spring.

Figure 7. Benchmark injector spring fault.

- Metallographic results indicate a benchmark in the form of a fault, which indicates fatigue fracture (fatigue fracture). The initial form of initial fracture from the fracture of the injector

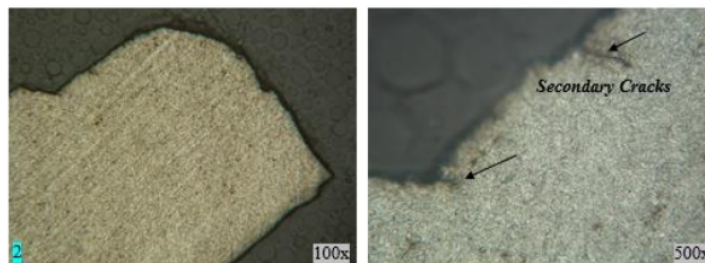
Figure 8 with 100x magnification and 500x there are secondary cracks due to dynamic loads. The secondary crack is caused when a break occurs and is not the cause of damage.

Figure 8. No.2 100x and 500x magnification.

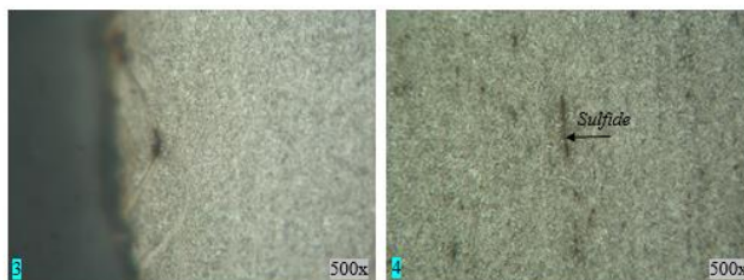
Figure 9. No. 3 in the edge area deformation of the structure due to the shot pining of the production process, the process will improve the performance of the spiral spring. While the number 4 microstructure is a marten site tamper and there is manganese sulphide. Where manganese sulphide is formed during the manufacturing process.

Figure 9. No 3 and No 4 Sulphide at helical compression spring.

Sulphide content in spiral spring microstructure is seen in the whole material quite a lot, possibly making the formation of early fatigue, with an indication of the beach mark in the form of a fatigue fracture in the injector spring.
